REPLACEMENT RESERVE REPORT FY 2012

WATERS EDGE CONDOMINIUM

FALLS CHURCH, VIRGINIA

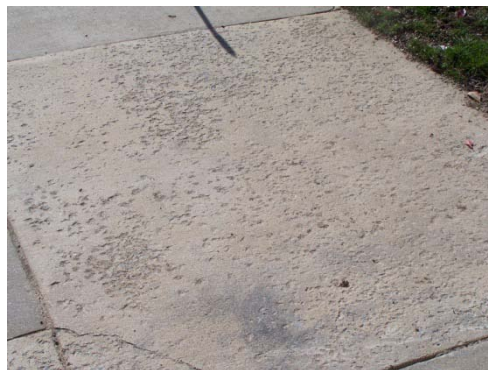
1. Trip hazard, 0.5 inch height difference.
2. Severe cracking.
3. Severe spalling
4. Uneven riser heights on steps.
5. Steps with risers in excess of 8.25 inches.

Photo 1 - Spalled sidewalk

Because it is highly unlikely that all of the community's concrete components will fail and require replacement in the period of the study, we have programmed funds for the replacement of 30% of the inventory and spread those funds over a 60-year timeframe to reflect the incremental nature of this work. This approach assumes a failure rate of 0.5% per year.

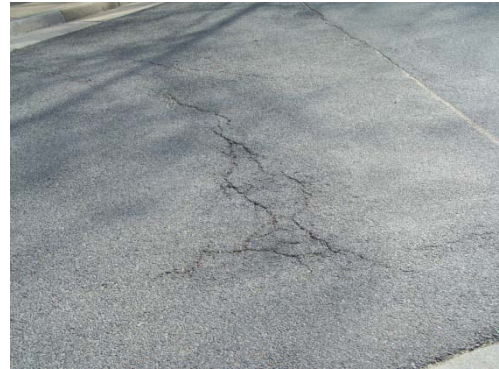
Asphalt Pavement. The site includes asphalt pavement for vehicle access and parking. In general, the asphalt pavement is in fair condition with multiple areas of defects. The Association maintains an inventory of 68,418 square feet of asphalt pavement

Photo 2 - Typical cracks

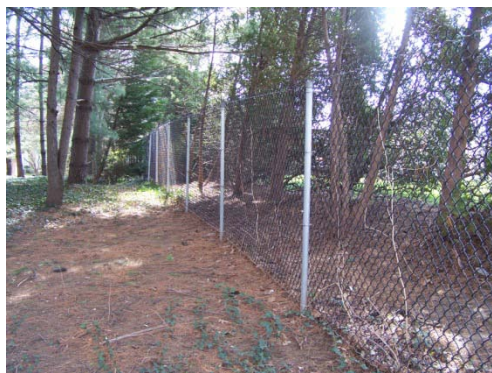
- Undermining. We noted several locations where erosion or settlement has resulted in the formation of a larger than normal gap between the bottom of the fence and the ground. This gap will allow small animals and objects to pass under the fencing. These areas will have to be regraded to close the gap.

Photo 3 - Chain link fence section

We understand that this fence is scheduled to be replaced this year.

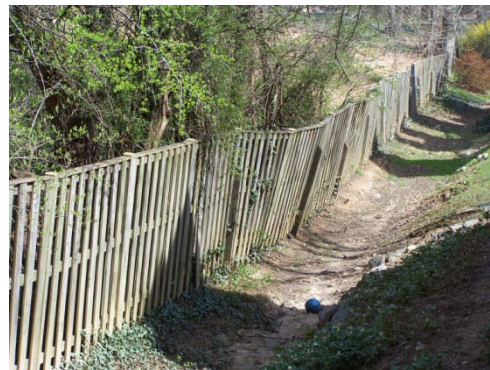
Photo 4 - Damaged wood fence

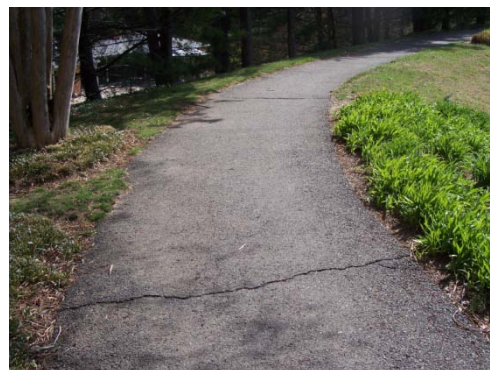
Asphalt Paths. The Association maintains an inventory of 3,660 square feet of asphalt path throughout the community. The overall condition of these paths is fair to poor with multiple defects throughout the community. The defects noted include the following:

- **Tree Root Damage.** There are locations where roots from trees planted near the asphalt surface have pushed up through the asphalt, causing cracks and heaving. Repair of these areas will require removal of the asphalt and the tree roots.

- **Crumbling.** Portions of the asphalt paths are failing due to crumbling. Crumbling is the final stage in asphalt failure. At this point, water has penetrated and damaged the base, leaving the asphalt unsupported. The asphalt then breaks into small, loose fragments. Crumbling poses a trip hazard. Repair will require removal of the failed asphalt and replacement.

Photo 5 - Asphalt path section

We understand that the asphalt path is to be replaced this year.

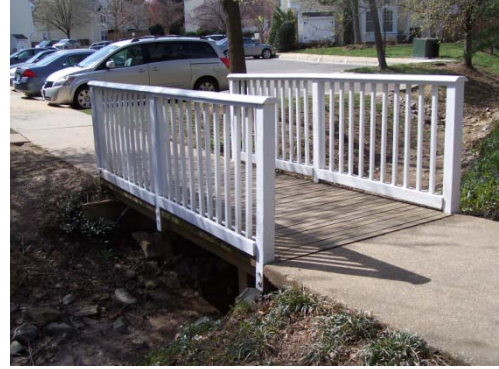
Wood Bridge. There is a wood bridge located along the asphalt path within the community. The overall condition of the bridge is good. For the Reserve Analysis, we have separated each bridge into three components, the wood deck, the structure, and the railing to reflect their different service lives.

Photo 6 - Wood bridge on path

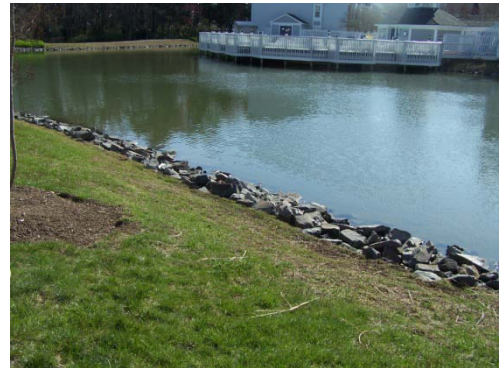
Riprap. The community has installed stone riprap along the shoreline to protect against erosion. In general, the riprap is in good condition.

Photo 7 - Riprap section

While riprap is considered to be a long-life item, with time and exposure the riprap can be undermined, silted, or washed away. Therefore we have included repairs to the riprap in the Reserve Analysis. Due to the incremental nature of the work, we have assumed that ten percent of the rip rap will require replenishment every ten years.

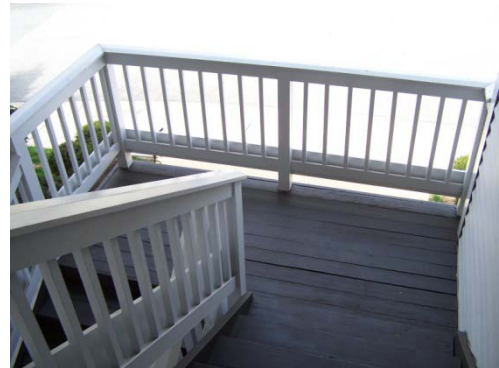
Pressure Treated Wood Steps. The community has a set of exterior steps that are constructed from pressure treated wood. The steps currently are in good condition.

Photo 8 - Building steps

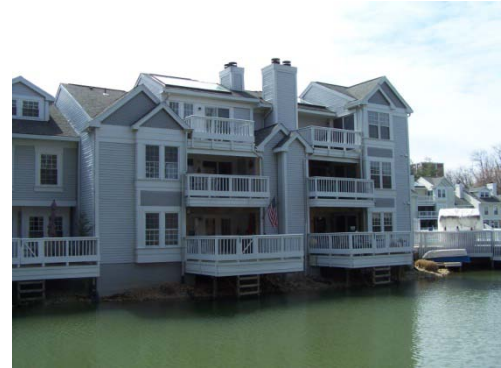
Wood Decks. Wood decks and railings can be difficult to maintain. By design, a large portion of the decks and railings contain horizontal surfaces. Water tends to stand on the surfaces and soak into the wood. As the sun dries and pulls the moisture out of the wood, the wood shrinks and cracks. The wood decking material, as well as the handrails, should be repaired or replaced and then sealed every two to three years.

Photo 9 - Typical decks

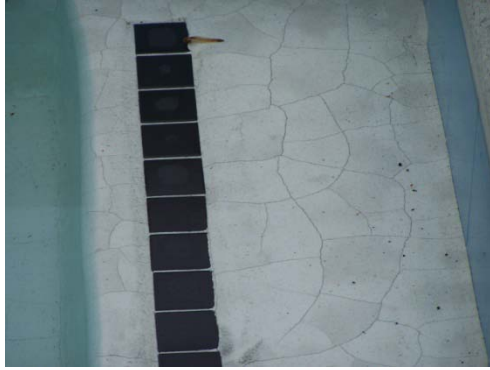
Photo 10 - Cracks in pool whitecoat

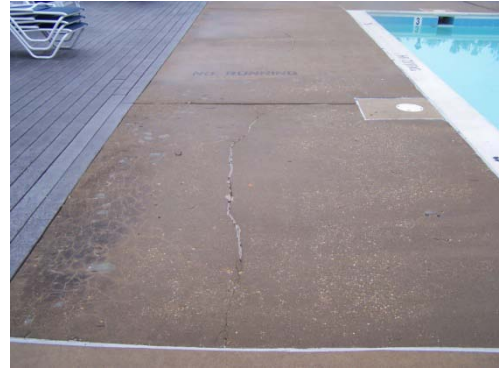
Photo 11 - Cracks in concrete deck

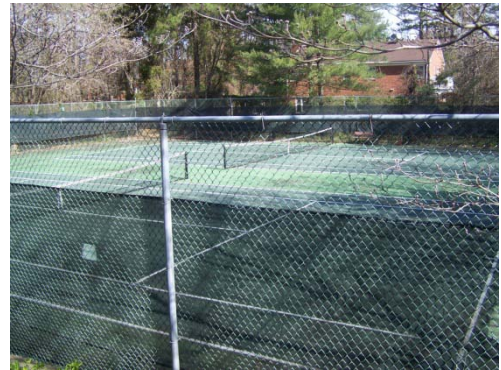
Tennis Courts - Asphalt. The community maintains two tennis courts. The overall condition of these courts is poor. Listed below are the major components of the tennis court facilities:

- **Asphalt Pavement.** The asphalt pavement for the tennis court is in poor condition with cracks and splits that extend into the playing surface. We have assumed a service life of 20 years for the asphalt.
- **Color Coat.** The color coat on the tennis courts is in poor condition with some major defects in its finish.
- **Fencing.** The fencing installed around the tennis courts is chain link and in fair condition. The fencing has damage in several locations. We have assumed that the fencing will be replaced when the asphalt pavement is replaced.
- **Net Posts.** The net posts are in fair condition. We have assumed that the new posts will be replaced when the asphalt pavement is replaced.
- **Wind Screen.** The wind screen installed on the fencing at the tennis courts is in good condition.

Photo 12 - Tennis courts
