# C-30929 - Waters Edge Condominiums

# NV Roofing Report

**Action Performed:** Roof / Skylight Inspection

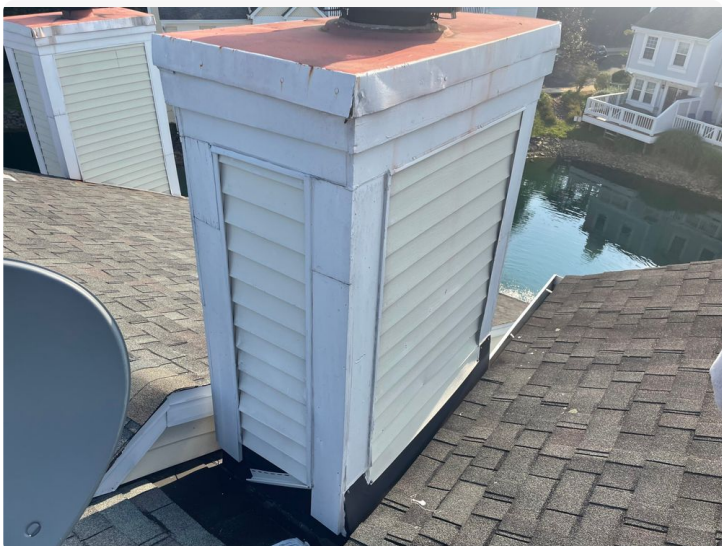
Loose Chimney Cap - As Pictured Below

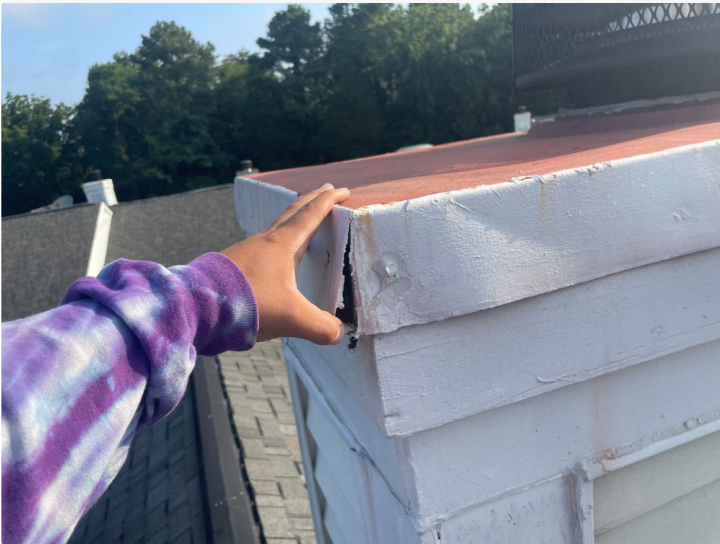
Open Seams at Chimney - As Pictured Below

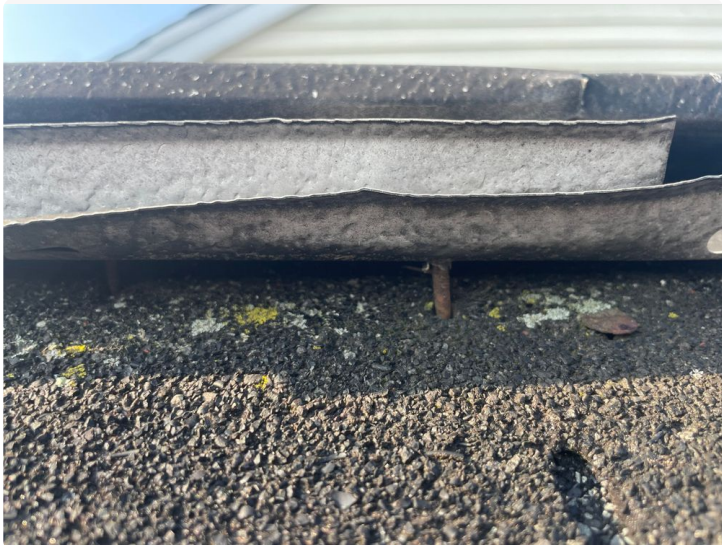
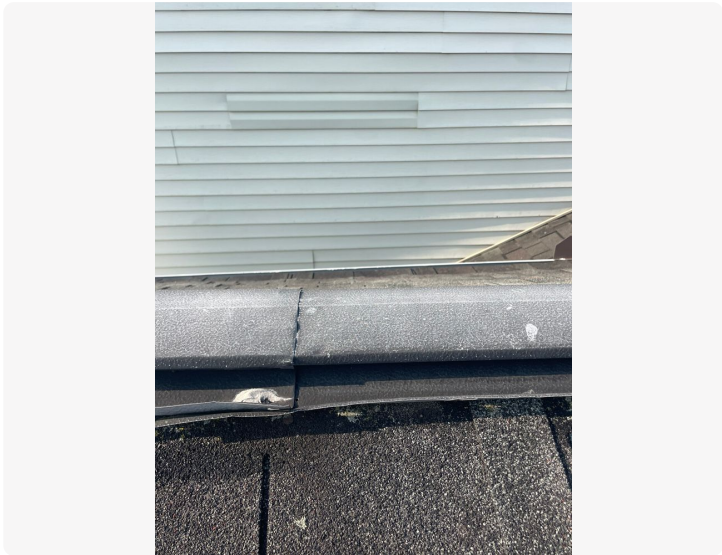
Damaged/Loose Ridge Vents - As Pictured Below

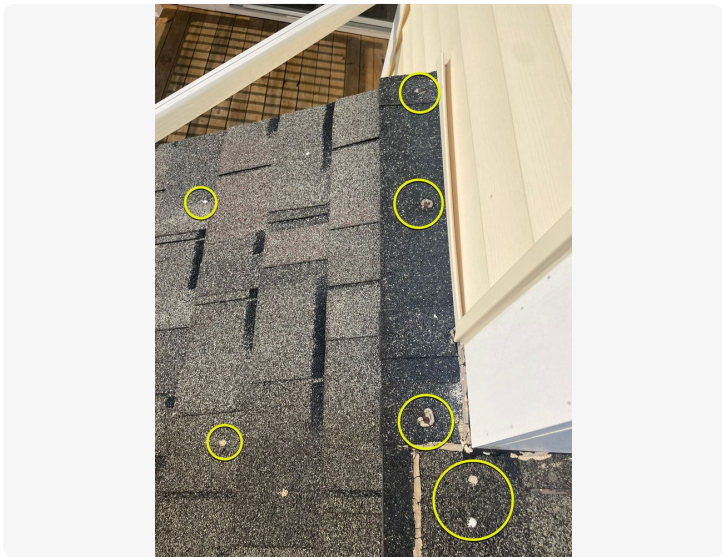
Exposed Nail Heads / Nail Pops - As Pictured Below

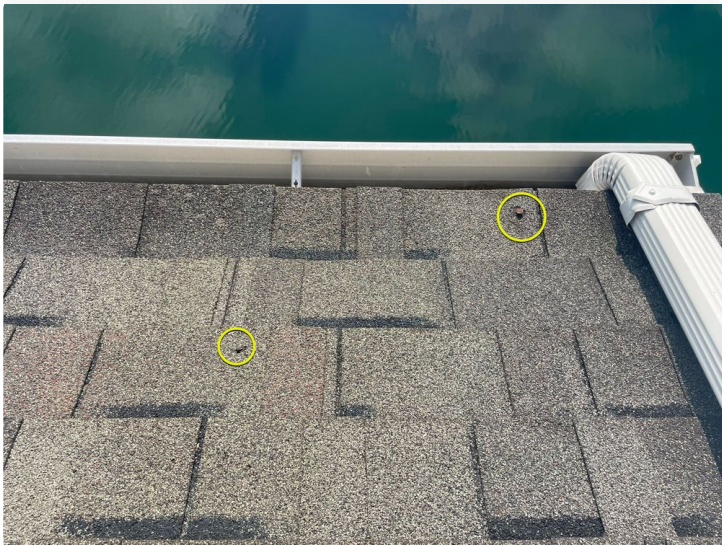
Exposed Nail Heads / Nail pops - As Pictured Below

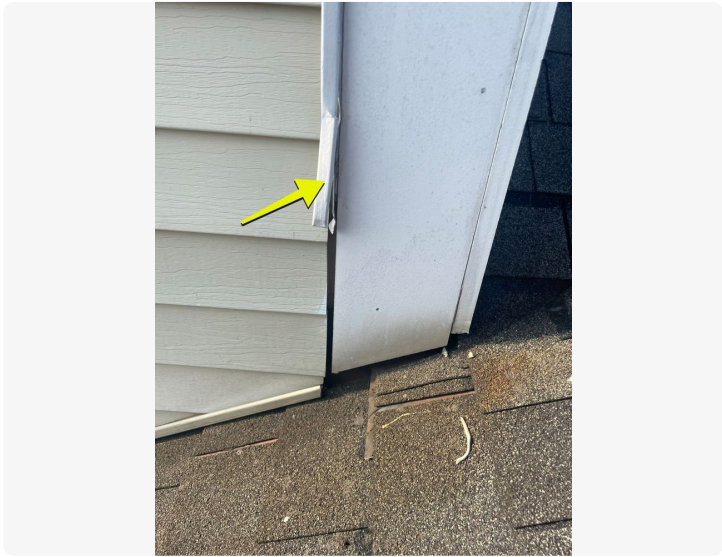
Deteriorated Sealant at flashing

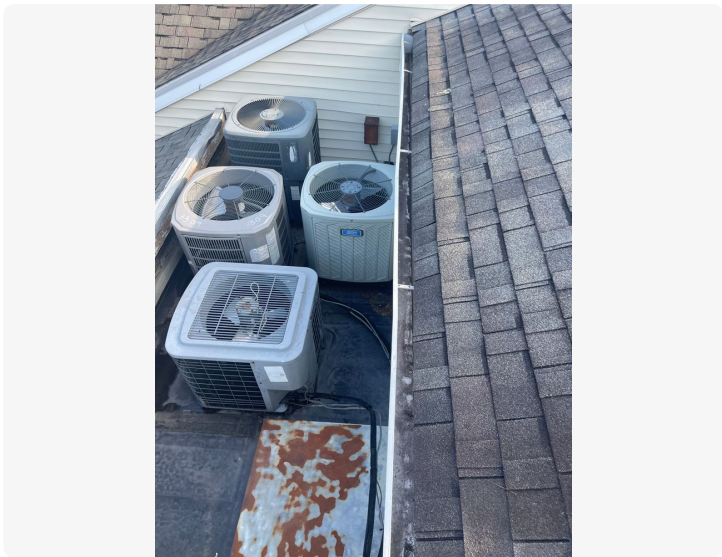
Flashing in good Condition, Vent rusting

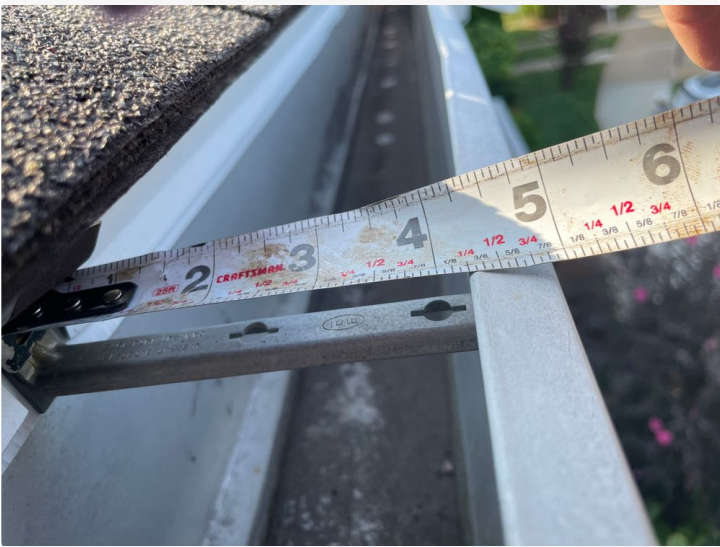
Loose Gutter hangers - As Pictured Below

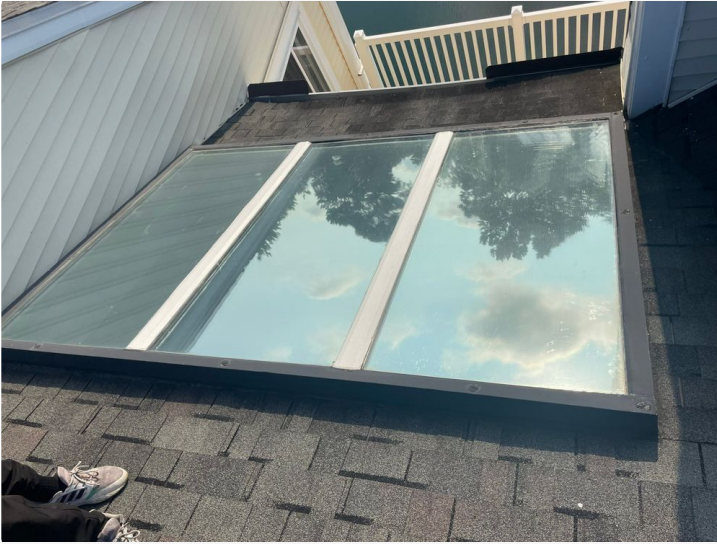
Based on our inspection we believe the skylights are the source of the leak. The gaskets are failing and the the glass is separating from the metal frame assembly.

Skylight #1 -The gaskets are failing and the the glass is separating from the metal frame assembly.

**Further Action Required: *Skylight Replacement & Roof Maintenance***

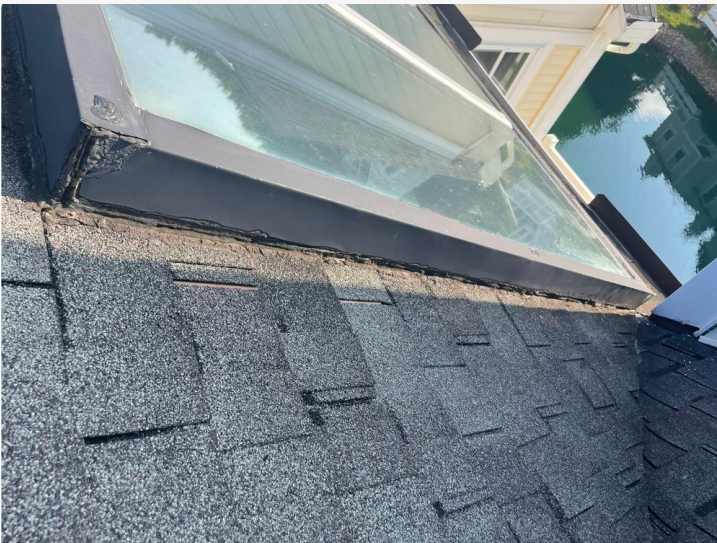
The gaskets are failing and the the glass is separating from the metal frame assembly.

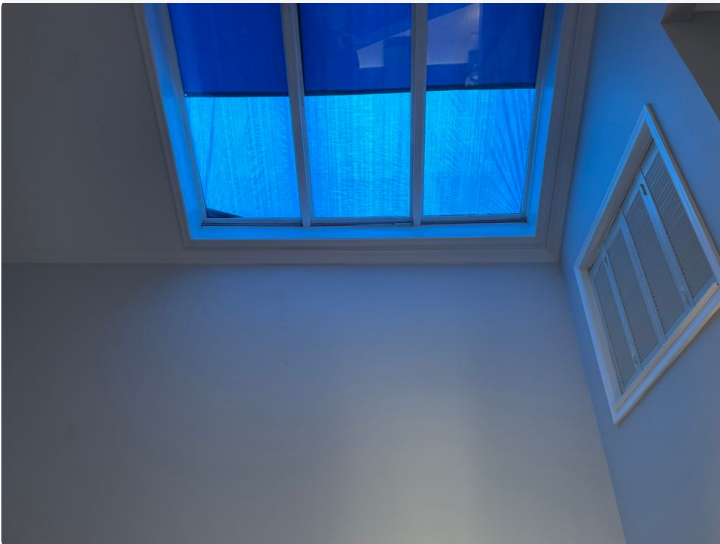
Dispatched technicians to perform roof & skylight inspection. Upon arrival it was noted that a tarp over skylight #2 was installed by others with cap nails causing damage to shingles. NV Roofing did not remove the tarp to inspect the skylight as it may have caused more damage to shingles. Inspected skylight #2 from inside of the unit and found water stains and water dripping down the wall, and deteriorated sealant around skylight #1 as well as a damaged gasket.

Skylight #2 - Tarped - Needs to be Replaced - As Pictured Below
