RELIABLE ENGINEERING

Project # J22-1104

Re: Revised Roof Evaluation Report
Water's Edge Condominium
Falls Church, VA 22041

Water's Edge Condominium
Property-Wide Roof Replacement Project
Four-Year Phasing Plan
November 9, 2022

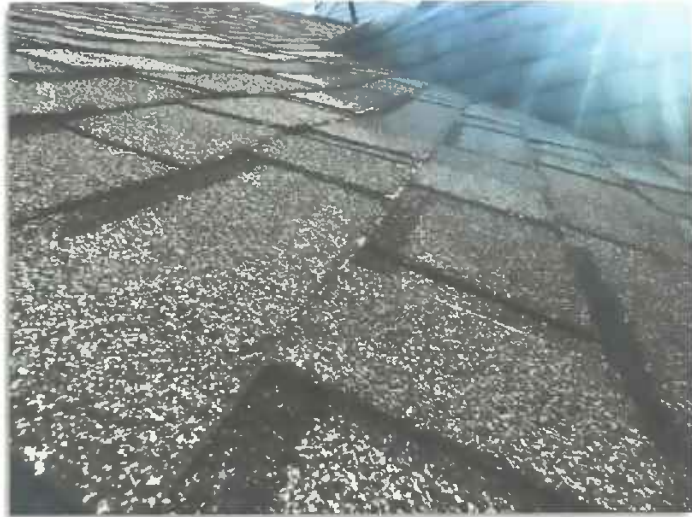
1. The shingles were brittle, and the fiberglass reinforcement was exposed throughout the community.

1. Remove and dispose of the existing shingles, felt underlayment, metal flashings, etc. down to the plywood sheathing.
2. Remove and reinstall the existing skylights to perform the roofing work. We recommend including an option for Unit Owners to purchase new skylights as part of the project.

4. Install new architectural asphalt shingles including, but not limited to, new synthetic felt, ice & water shield, 0.032-inch metal flashings, etc. in a manner to obtain a twenty (20) year material & labor warranty from the roofing manufacturer.

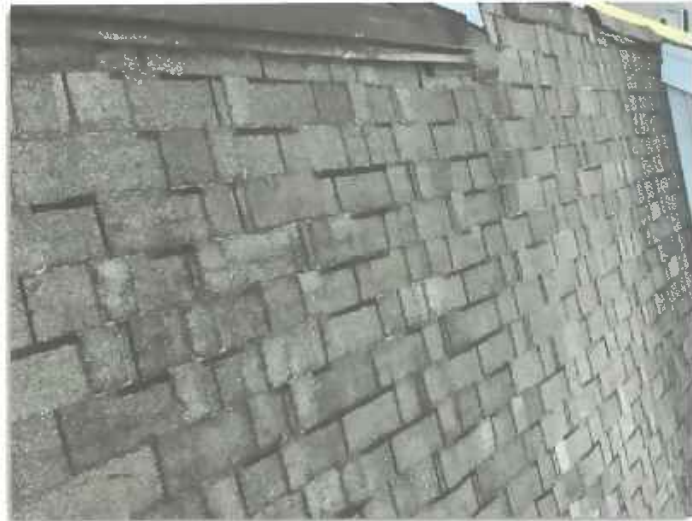
2. The shingles were worn with severe aggregate loss.

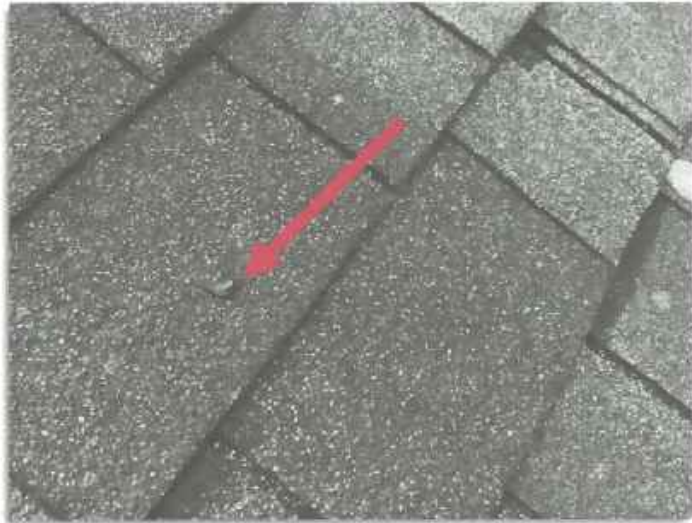
3. There were widespread exposed (unsealed) nails in the field of the roof as well as along the metal ridge vent. This condition leaves roof susceptible to water intrusion.

12. We recommend preventative maintenance of the roofs in Phases II and III be completed due to the project extending over a multi-year period. The work would mainly focus on applying roof cement to exposed fasteners to prevent future water intrusion issues.

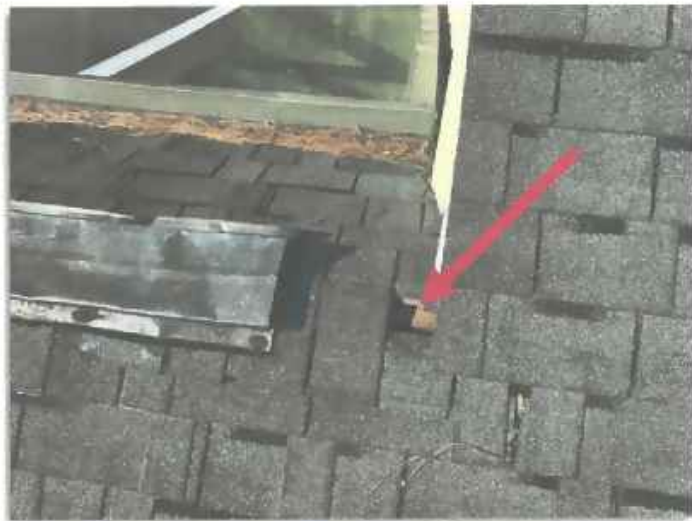
4. There were a few apparent large holes in the shingles that are water entry points. We notified the Property Manager of these locations to be repaired. Refer to the Urgent Repairs section of this report for more information.

1. For Bldg. (3300-3310 Lakeside View), the opening in the side wall at the gutter line needs to have a metal divert flashing installed.
2. For Bldg. 2 (3301-3315 Lakeside View), seal the fasteners/abandoned holes or replace the shingles that were damaged from the tarp installation above Unit 3311.
3. For Bldg. 5 (3346-3360 Lakeside View), install vinyl siding where missing and new metal divert flashing at the gutter line.
4. For Bldg. 6 (3317-3331 Lakeside View), install siding where missing at base of the chimney (roof line).
5. For Bldg. 16 (3417-3423 Lakeside View), install new shingles where missing adjacent to the metal ridge vent.
6. For Bldg. 17 (3409-3415 Lakeside View), install siding where missing along the side wall.
7. For Bldg. 19 (3375-3381 Lakeside View), install new shingles where missing at roof ridge.

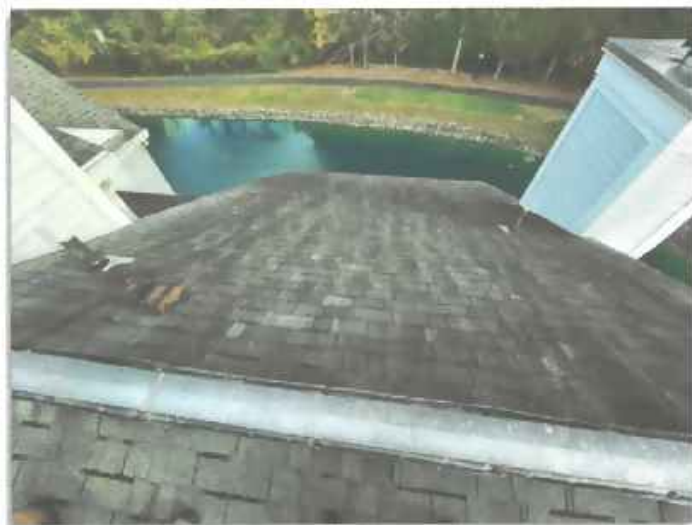
5. There was a build-up of "blue-green algae" on the shingles. This is typical for the age of the building.

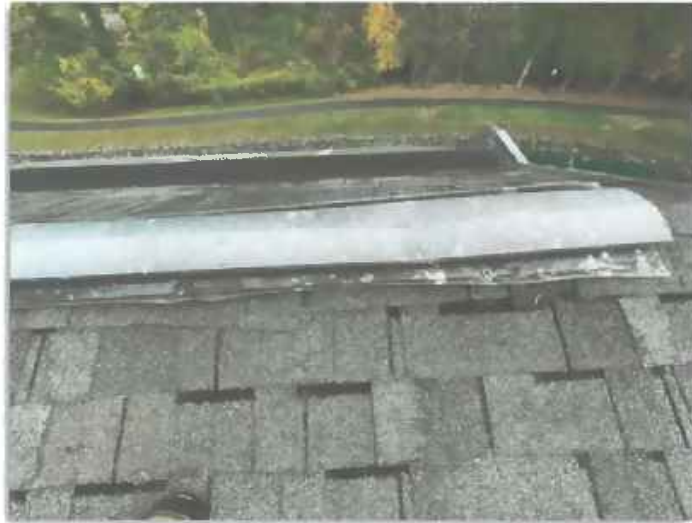
6. In general, the existing metal ridge vents were damaged (crushed) due to foot traffic and there were multiple unsealed fasteners.

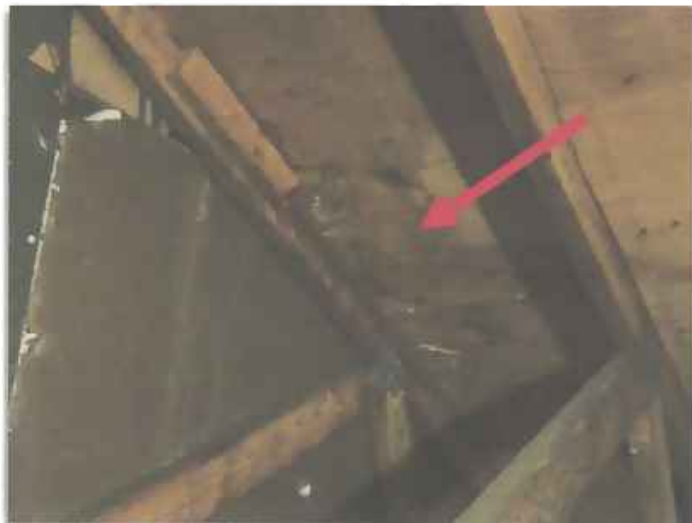
7. The FRT plywood was in relatively fair condition with some isolated weak ("soft") spots most likely due to water damage or lack of metal panel sheathing clips. Photograph from within the attic of 3317 Lakeside View depicting isolated area of plywood deterioration from a past water leak.

3. Remove and replace the existing fire retardant treated (FRT) plywood sheathing. We suggest including an allowance of 20% of the roof area for this work.

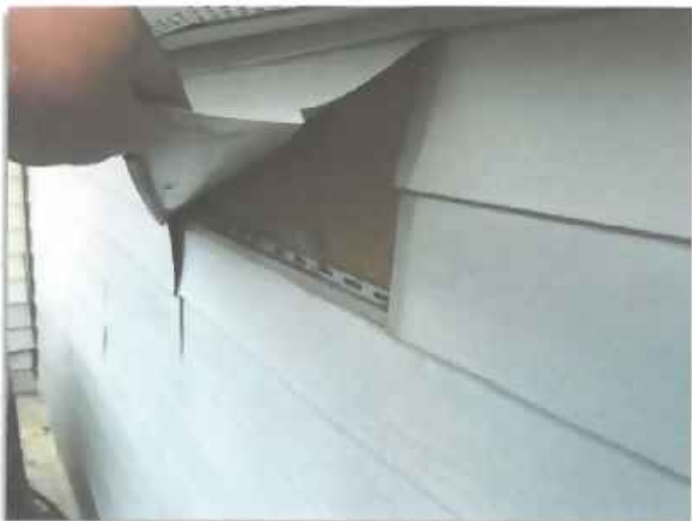
8. There was no air/vapor barrier behind the vinyl siding, just the gypsum wall sheathing. This condition leaves the exterior wall susceptible to water intrusion during wind driven rain (i.e. water can migrate between the vinyl siding seams and into the building from holes/joints in the gypsum panels).

- c. Install new self-adhering air/vapor barrier over the existing gypsum sheathing and counter-flash the new roof metal apron/step flashing.
6. Remove and replace the color-coated aluminum trim flashing. Work should include replacing deteriorated 1x8 rake board (trim).

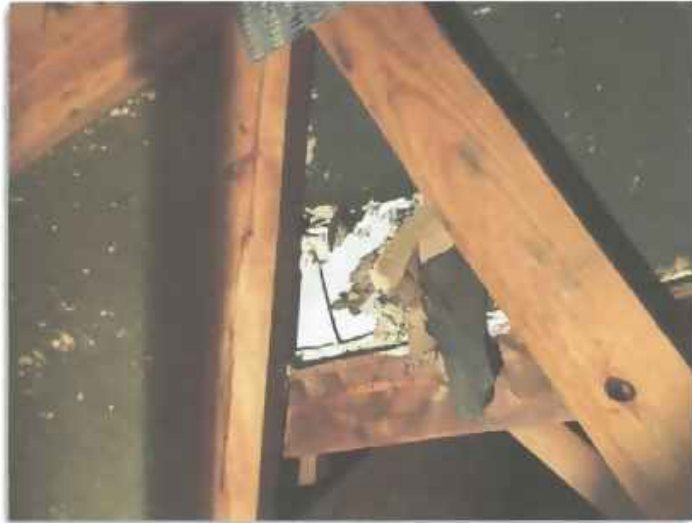
9. Damaged gypsum sheathing noted during one of our interior attic inspections.

- a. Remove and replace the existing vinyl siding at and above the roof line.
 - b. Perform needed repairs/replacement of the existing gypsum sheathing.

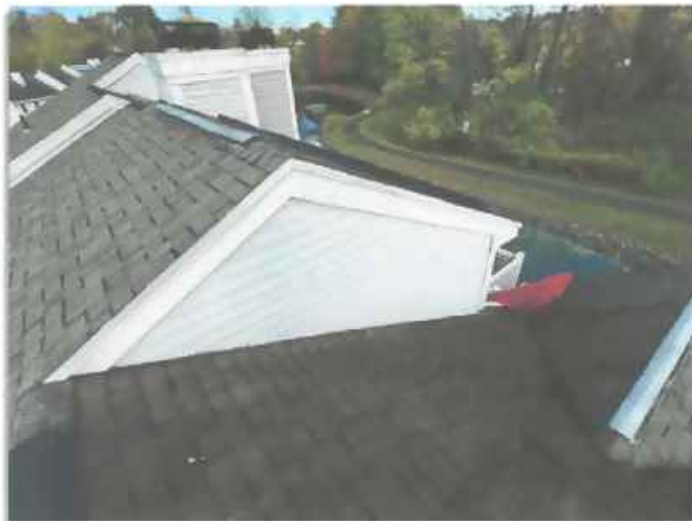
10. Typical view of a raised side wall clad with vinyl siding and wood trim wrapped with metal flashing.

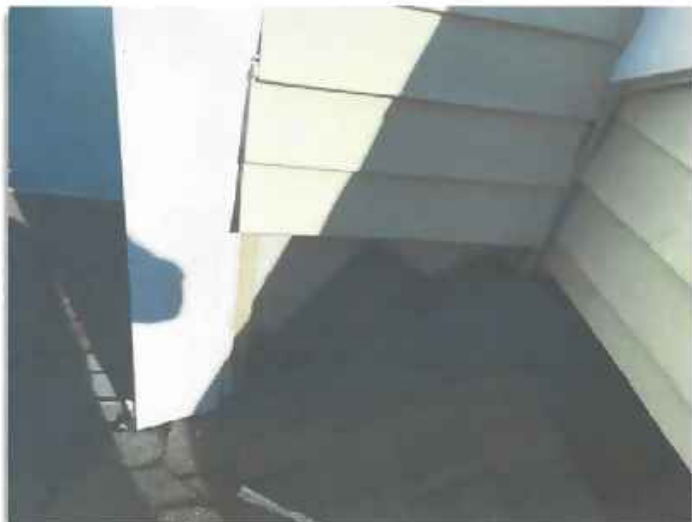
11. Vinyl siding was missing in a few areas presumably due to wind blow-off from the fasteners not secured into the wood framing (i.e. nails were secured to only the gypsum sheathing).

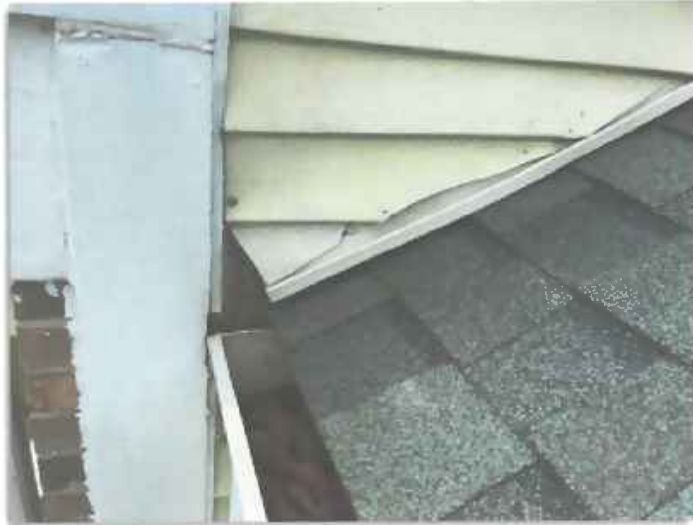
12. There were multiple openings in the raised side walls that could allow water to bypass the roofing system.

5. We recommend that the siding region above the roof line (i.e. side walls and chimneys) be addressed to provide a watertight condition. Otherwise, wind driven rain could migrate behind the siding and bypass the new roof system. The scope of work would include:

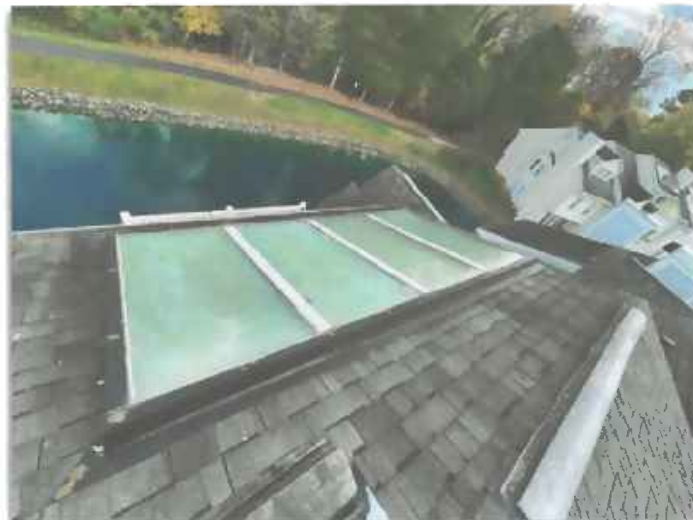
13. Many of the skylights were in poor condition with failed gaskets and “cloudy” glass.

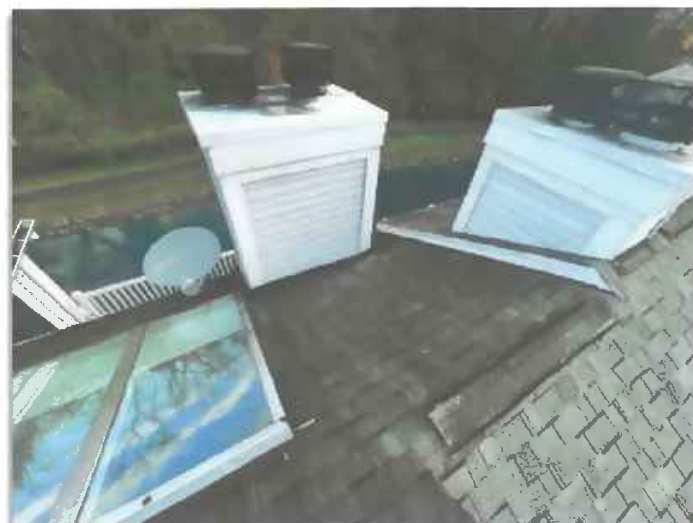
14. There were several chimneys throughout the community that were loose/unstable. The chimneys are presumably wood-framed and clad with vinyl siding and wood trim.

1. Further evaluate the loose (unstable) chimneys to assess the condition of the wood framing and attachment(s) to the building structure. This work will entail partial removal of the vinyl siding, wood trim, and gypsum sheathing to expose the wood framing. We have already contacted a local roofing contractor and requested pricing to assist us with this follow-up exploratory work. Based on our findings, we will include needed chimney framing repairs to the roof replacement design. We are waiting on the proposal from the roofing contractor and will submit to the Property Manager (along with our additional fees) for review and approval prior to proceeding with this work.

9. Remove existing chimney caps and replace with new stainless steel (soldered) caps.
10. Depending on the follow-up evaluation of the chimneys, perform carpentry repairs and/or re-securement of the chimneys. The work should include replacing the siding and trim.

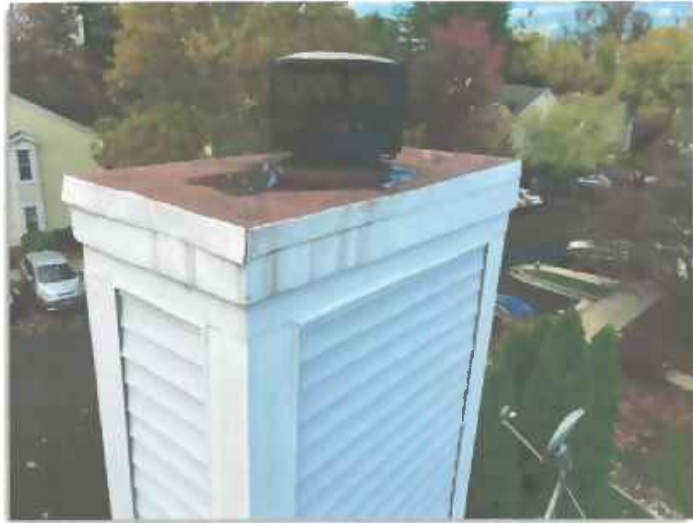
15. The chimney caps were in poor condition with mild (surface) rust and low points that hold (collect) water.

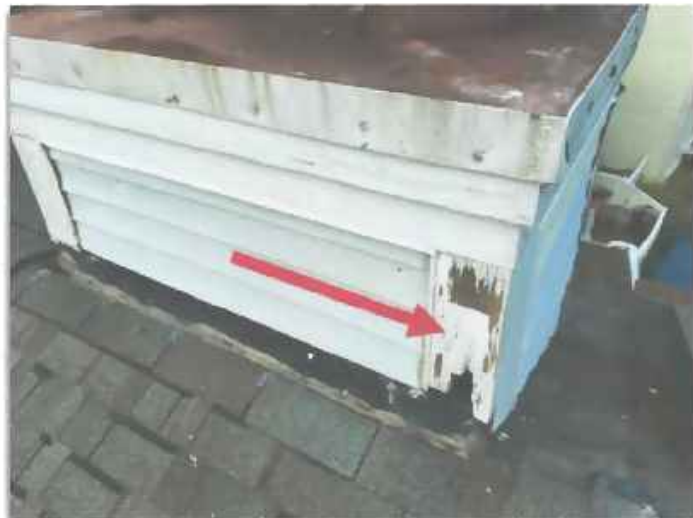
16. The wood trim was deteriorated (rotted) in numerous areas.

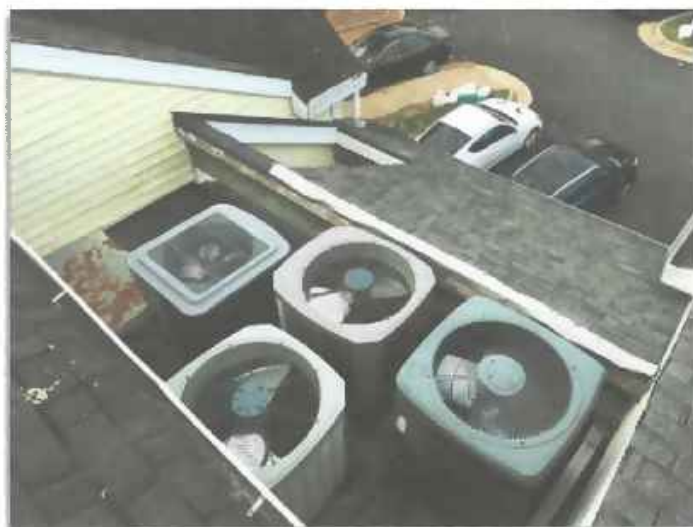
17. On the larger buildings, there is a low-sloped roof area (above the building entrance) that houses heat pumps. The original roof covering is a metal roof, which have been overlaid with a single-ply membrane (i.e. both EPDM and TPO were noted) at multiple areas.

11. Alternate: Remove and replace the low-sloped roof coverings on the larger buildings. This work would require the existing heat pumps to be temporarily removed & reinstalled.
